FR Bearing Spacer Issue Review

September 16, 2015

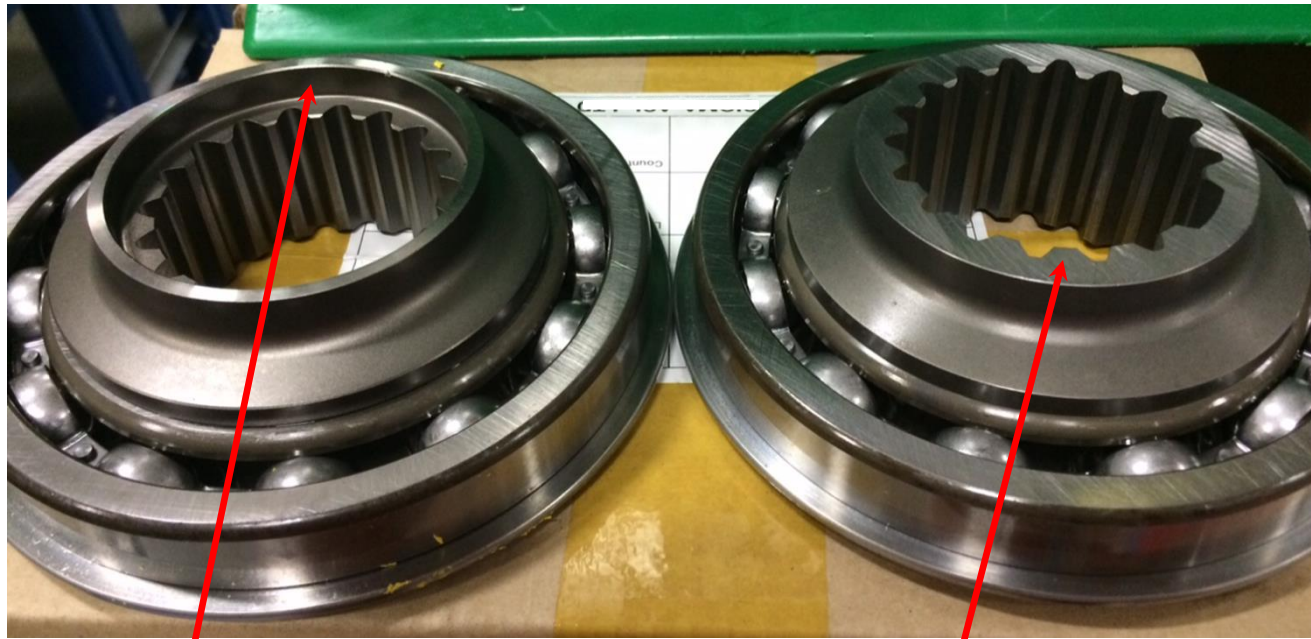
- FR and FA models of manual transmissions built on same assembly line
- Main shaft key design differences between two models requires feature differences on bearing spacer for each model
- FA bearing spacer assemblies mixed with FR stock and were used for FR builds
- There are a total of 5 known defective units at present, all were built during 1st shift on 12/19/14

FR assembly w/ clearance for
main shaft key

FA assembly w/o clearance for
main shaft key

- Incorrect aux bearing spacer installed causes main shaft key to be forced out of position allowing the reverse gear to move axially on the main shaft
- When the transmission shift lever is moved from reverse to neutral or low gear position the axial movement of the reverse gear can result in continued engagement of the gear and sliding clutch and torque being transmitted when main clutch is engaged (clutch pedal released)
- Potential failure modes
 - Transmission mechanically locked (reverse and low gear simultaneously engaged with shift lever in Low position)
 - Unintended vehicle movement (reverse gear engaged with shift lever in neutral position)
 - Both will result in a truck down situation if failure occurs
 - Failure modes related to shift lever movement out of reverse, not idling or driving conditions
- Field issues to date have all been low mileage (less than 5,000 miles)

- Eaton process
 - Transmissions will be inspected to determine which spacer was installed
 - If determined to have incorrect spacer the transmission will be repaired or replaced at Eaton's expense
